# Investigating the Response of a Small Urbanized Watershed to Acute Toxicity Events via Analysis of High-frequency Environmental Data

Holly Adelle Clark<sup>a\*</sup>, Walter M. McDonald<sup>b</sup>, Vinod K. Lohani<sup>c</sup>, and Randel L. Dymond<sup>b</sup>

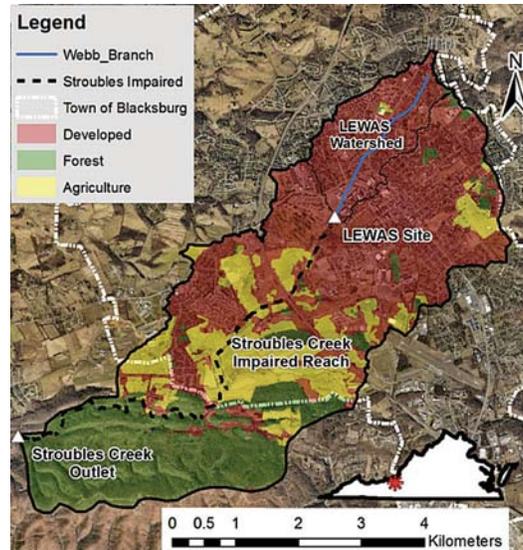
Figure 1. Stroubles Creek watershed land use and LEWAS lab location.

Stroubles Creek flows approximately nine miles from Blacksburg, Virginia to the New River, and is classified as a second-order stream within the New River Watershed. Since the establishment of communities in the region beginning in 1740, the riparian health of the Stroubles Creek Watershed has fluctuated dramatically.<sup>1</sup> The major land use changes that have occurred as a result of settlement over the past 270 years have impacted the watershed's capacity to endure the ecological consequences of human activity. The Stroubles Creek Watershed has a history of impairment, as defined by the U.S. Environmental Protection Agency (EPA). In 1996, Stroubles Creek was found to be benthically impaired, and TMDL studies in 2003 revealed that sedimentation was a major cause of these impairments.<sup>2, 3</sup> In the past decade, restoration efforts have been implemented to help restore the riparian health of the Stroubles Creek Watershed. **Figure 1** illustrates the location of the watershed including the land use distribution and impaired reach of Stroubles Creek.

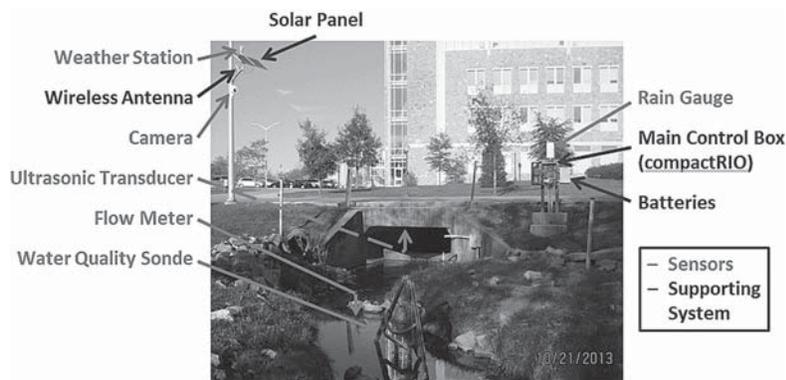
Water and weather parameters are measured and recorded by multiple in-situ sensors at the outdoor location of the LEWAS lab. The in-situ sensors include a Sontek Argonaut-SW Acoustic Doppler Current Profiler (ADCP) that is mounted on the streambed and measures stage and velocity every minute. Meteorological conditions at the site are recorded with Vaisala Weather Station equipped with sensors capable of measuring air temperature, pressure, and relative humidity every one minute, wind speed and direction every five seconds, and precipitation instantaneously using a piezoelectric sensor that detects the impact of individual raindrops. Water quality parameters including temperature, pH, turbidity, specific conductance, dissolved oxygen, oxidation reduction potential, percentage of saturated dissolved oxygen and total dissolved solids are measured with a Hach MS5 Hydrolab Sonde and collected every three minutes. A tipping-bucket rain gauge has also been installed at the site to verify and calibrate precipitation readings from the weather station. An ultrasonic transducer has been installed to provide an additional flow measurement through stage readings behind a weir located in the culvert upstream of the site. A diagram of the physical layout of the field site is illustrated in **Figure 2**.

**Figure 2.** LEWAS lab field site on Stroubles Creek.

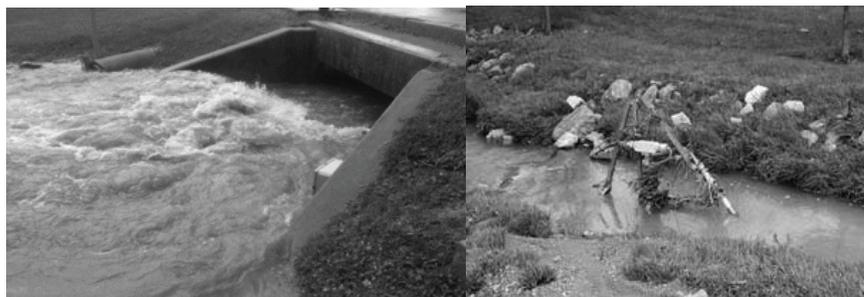
Due to the high volume of water that flows past the LEWAS site during significant precipitation events (**Figure 3**), frequent sonde and ADCP sensor maintenance and occasional repairs have to be performed. These repairs must be completed as efficiently as possible to reduce the amount of time that the site is unmonitored. Routine calibrations require the sensors to be removed from the stream, cleaned in a laboratory environment, and reset with standard solutions for each parameter at approximately three-week intervals. The frequency of calibration is partly determined by the drift in measurements that have been observed since the previous procedure; if an increased margin of error is noted, then calibrations will be performed more frequently.

During high flow events, debris in a variety of mediums (substantial rocks, urban garbage, vegetation, etc.) that has been channeled through the stormwater network arrives at the site and can potentially collide into the ADCP and sonde (**Figure 3**). This can cause erroneous measurements and sensor damage and disturb the riparian ecosystem by damaging existing habitat and increasing turbidity and other pollutants. Debris that accumulates around or within the sensors must be manually removed to maintain accurate data.

**Figure 3.** Flooding from rain event at LEWAS field site & Hach MS5 Hydrolab water quality sonde covered in Debris; Sedimentation deposits on south stream bank.

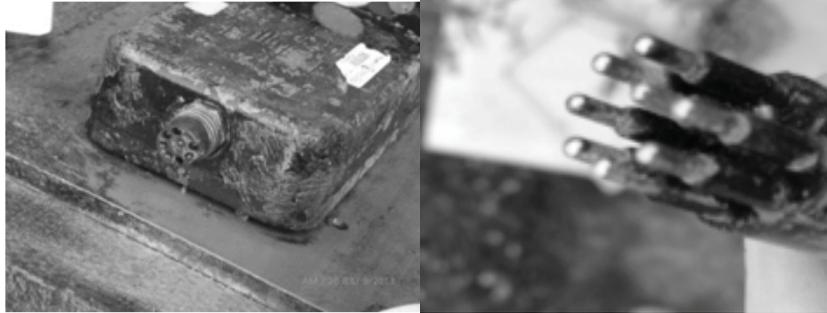
The following example describes how damage to a sensor results in repair, redeployment, and calibration efforts. In July 2013, the ADCP underwent a series of repairs following severe rain events to address internal electrical damage. The issue became apparent when measurements were not being recorded by the instrument, and it was deduced that the connection between the conduit and the instrument had been exposed to water for a prolonged period of time. This caused water to leak into the instrument, and the pins of the male connector to become corroded (**Figure 4**). The lack of a functional water-tight seal could have resulted from a number of situations including the accumulation of biofilm around the port preventing a flush seal, debris during storm events impacting the port and breaking the seal, or improper insertion of the cord resulting in a leak.

**Figure 4.** ADCP flow-meter with corroded biofilm accumulation and corroded conduit pins.

To repair the ADCP, it was removed from the streambed and the build-up of biofilm was removed with a poly-fiber brush. Electrically-conducting silicone spray was deposited into the female ports of the ADCP to create a water-tight seal. The damaged conduit wire containing the connector was spliced together with a replacement cord to achieve the necessary length using a soldering connection. The connector was then inserted into the ports of the instrument.

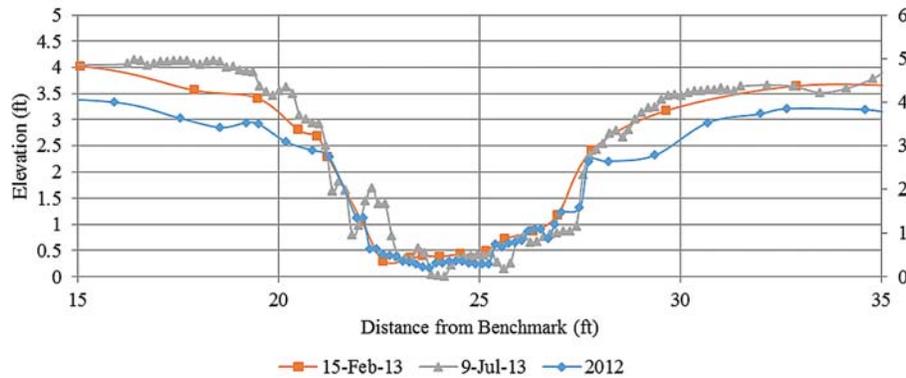
After the ADCP was returned to the streambed, the stage-area rating of the cross section was calibrated by conducting a new cross-section survey. The streambed is composed of cobbles and pebbles with alluvia-floodplain deposits of stratified unconsolidated silt, clay, and sand with lenses<sup>1</sup>. During a storm event, a stream's cross section can sometimes be altered dramatically due to erosion and sedimentation caused by the high volume and velocity of water passing through. The ADCP estimates flow based on the index velocity method<sup>9</sup> which takes the velocity and stage readings measured by the device and applies them to index-velocity and stage-area ratings respectively. If the cross section of the stream changes due to sedimentation or erosion it will affect the stage-area rating and subsequently the volume of water estimated by the ADCP. A cross-sectional profile survey was performed at the site in two locations (at the ADCP and the calibration cross section) to generate the new cross section of the stream. The cross-sectional profiles were recorded using a Leica Total Station and were imported into Microsoft Excel to generate a new graphic cross section of the stream. **Figure 5** represents the changes to the cross sectional profile of the stream during three separate surveys during the spring of 2012, spring of 2013, and summer of 2013. The surveys are aligned by a benchmark located along the left bank with the vertical datum representing the point of lowest elevation.

**Figure 5.** Seasonal comparisons of cross sections of Stroubles Creek.

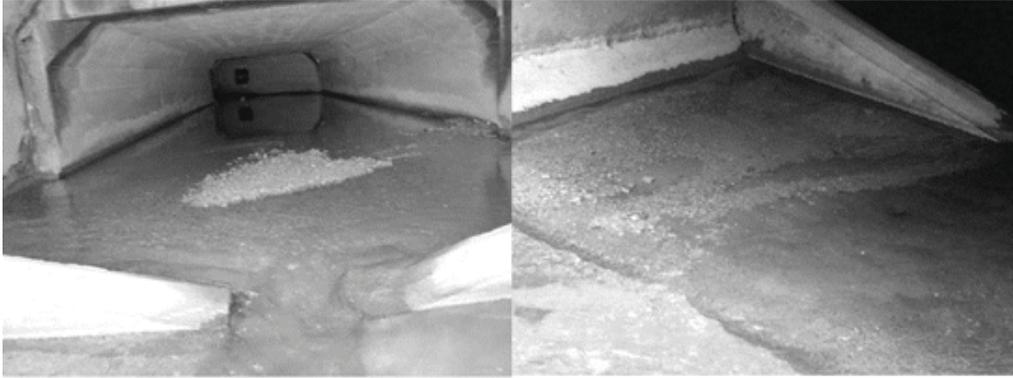
An example of the sedimentation at the site is shown in **Figure 6** which illustrates the sediment deposition that accumulated in a culvert located 10 meters upstream of the LEWAS in-stream sensors. The mounds of sediment shown in the figure demonstrate the amount of sediment that is routinely transported through the stormwater network and eventually into the Duck Pond. The Duck Pond has had a history of poor water quality, much of which is attributed to sediment. The

**Figure 5.** Sedimentation deposits in culvert and weir (looking upstream).

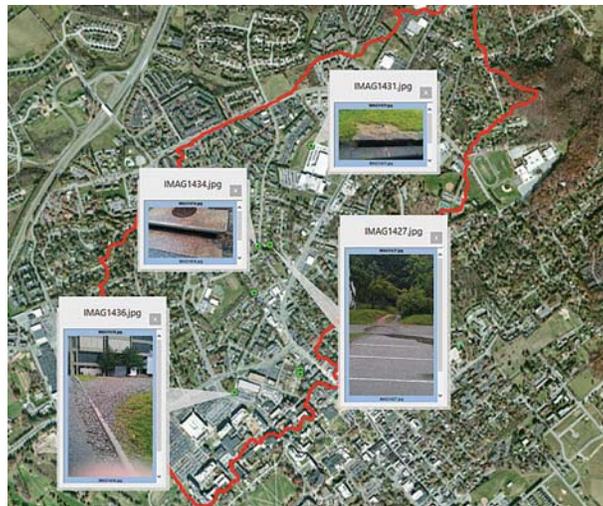
To investigate the sources of sedimentation from flash events that deposit large amounts of sediment near the site, a physical watershed investigation was conducted. Possible sources of sedimentation were documented through geo-tagged pictures during a summer storm event. Pictures captured various sources of sedimentation as well as travel paths of the sediment, such as small streams and stormwater inlets that were visibly transporting and storing sediment during the runoff period. These pictures were uploaded and georeferenced using GIS software to document the most likely sources of sedimentation (**Figure 7**). This information was combined with stormwater network data described in **section 3.3** to determine leading sources of sedimentation.

**Figure 6.** Sedimentation survey map.

As an example, the stormwater network data along with the watershed sedimentation survey was combined to provide clues to the probable sources of sedimentation during flash storm events. The stormwater network map was used to properly delineate the watershed area, which provided the area of possible pollutant sources within the town. The geotagged photos within GIS were used to determine possible sedimentation source locations within the watershed and the stormwater network was used to determine the routes for each source. This information was finally used to map highly probable areas that contribute to sedimentation at the field site. The leading sources of sediment runoff within the watershed were identified as construction sites and gravel parking lots, many of which are adjacent to the main reach of Webb Branch. These sources were found to contribute sediment during flash storm events that cause spikes in turbidity and deposits of sediment at the site and in the Duck Pond, which will again require dredging and channel modifications over time. Identifying these sources can help lead to solutions by informing stormwater managers and decision makers about sedimentation impairments within Webb Branch watershed.

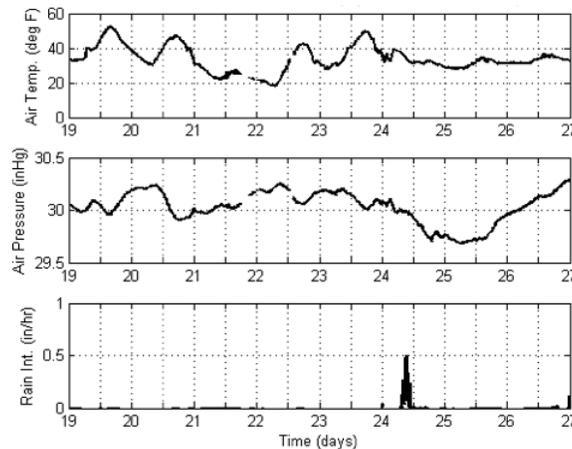
The previous research methods allow the LEWAS site to effectively analyze events in the watershed that are captured by the LEWAS environmental sensors. The following case study illustrates how the LEWAS watershed responds to an acute chloride toxicity event from a spring storm occurring over a two day period. Blacksburg experienced a spring storm over March 24–25, 2013, as indicated by the meteorological data collected by the weather station illustrated in **Figure 7**. The weather station detected a drop in air temperature and air pressure and a rise in rainfall intensity during the storm event.

**Figure 7.** Weather station data for duration of March 24–25, 2013 storm event.

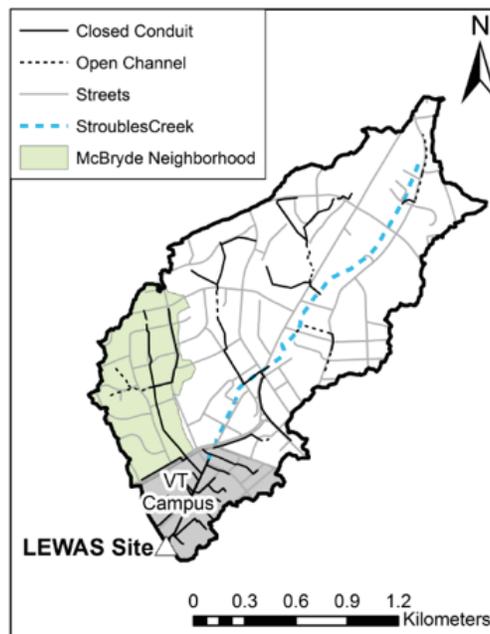
A significant portion of the McBryde neighborhood's stormwater conduits was successfully mapped out over the course of this summer investigation, thus improving the understanding of the contributing Upper Stroubles Creek watershed area. **Figure 8** shows the portion of the McBryde area (0.44  $\text{km}^2$ ) that was mapped as a result of this work in relation to the entire LEWAS watershed.

**Figure 8.** Portion of McBryde stormwater network system mapped during summer 2013.

The stormwater network maps created as a result of the survey process ultimately provide a visual explanation of how pollutants and sediment arrive at the LEWAS lab field site. Knowing the path that a pollutant travels can allow estimates to be made of time that lapses between a pollutant entering a given conduit and its presence recorded by the sensors at the monitoring site. By using the stormwater network map in **Figure 8** along with knowledge of the land cover, investigations into possible sources of pollution captured by the sensors can be conducted.

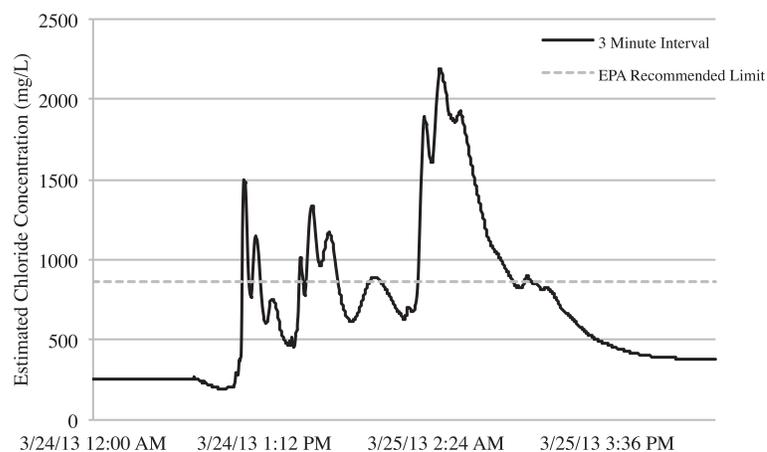
Results from a case study of a spring storm event suggest that there are substantial environmental consequences to the application of road salts and deicing solutions in the LEWAS watershed. The water quality sonde recorded multiple spikes in specific conductance at the field site during the March 24–25, 2013 storm event. Specific conductance represents the ability of water to conduct electrical current and can be used as a surrogate to approximate the amount of chloride in the water due to deicing solutions. **Figure 9** shows the estimated chloride concentrations over the duration of the runoff event as well as the EPA recommended acute toxicity limit. Acute chloride toxicity is the potential exceedance of a species tolerance to chloride caused by a sudden, one time, and high exposure. The U.S. Environmental Protection Agency (EPA) sets recommended limits of pollutants that are toxic in acute exposures for various freshwater organisms. The EPA quantifies an acute toxicity level for chloride as 860 mg/L<sup>11</sup>. As illustrated, the chloride concentration exceeded this limit on multiple occasions, indicating that the system was experiencing an acute toxicity event. (Unfortunately, the ADCP was not functioning during this event so the LEWAS was only able to capture water quality data.)

**Figure 9.** Measured chloride concentrations vs. EPA recommended concentration.

In addition to the EPA recommended limit, the toxicity thresholds of key indicator species can be used to determine the impact of the chloride. A professor in the Virginia Tech Biology Department explained that the fathead minnow (*Pimephales promelas*) is frequently used as an indicator species by researchers to gauge the health of a riparian ecosystem (J. Webster, personal communication, July 10, 2014). The acute toxicity limit of a fathead minnow, as determined by the EPA, is 860 – 2790 mg/L<sup>1</sup>. Because the fathead minnow is frequently found in Stroubles Creek, these high chloride concentrations are of concern and suggest that this event most likely created an environment that was toxic to the fathead minnow.
